Manhole Inspection Summary

Manhole # S11II_037MH

Insp Date: **6/23/09 1:08 PM**

Location Address: **3139 NORTH AVE**

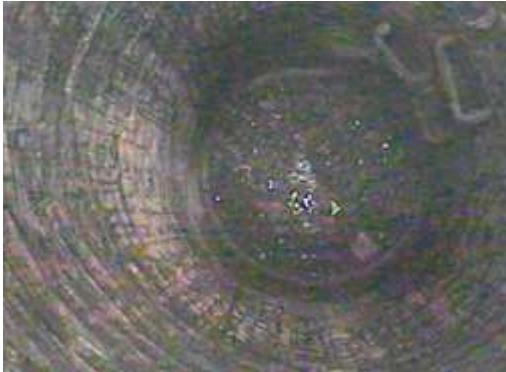
Defect 1

Count: **11** Missing: **8** ☐ Corroded

MISSING STEP

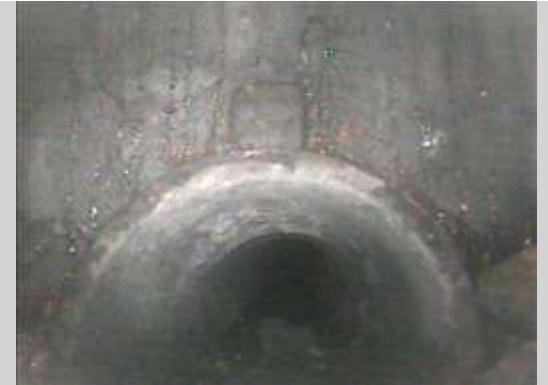
12 O'Clock Outflow

8 in. Circular Gravity Sewer
Pipe Out @ 12 O'Clock

Deposits: ☐ None ☒ **Mud** ☐ Sludge ☒ **Debris** ☐ Grease

Silt Depth: **1.5** (in.) Deposits Extent: **Light**
